Solution Summary: Golf mowers with QA5 reel cutting units - Premature wear of cutting unit frame when using grass catchers

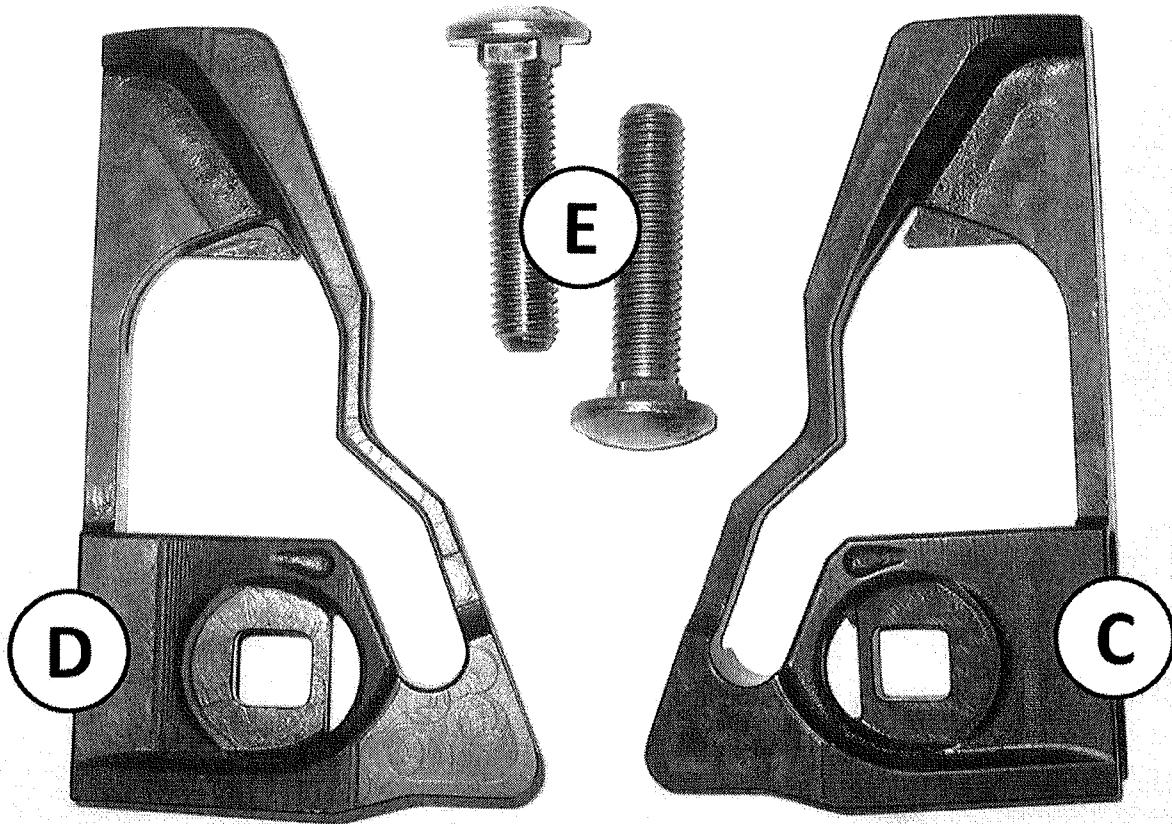
Grass catcher basket cannot be retained in QA5 cutting unit. See photo. [89960_1.jpg](#)

- Slots (A) in cutting unit side panels are excessively worn.
- Basket alignment rod (B) is excessively worn, cone shaped.

Steel basket rod can cause premature wear of Aluminum side panels during normal operation.

Do NOT replace worn cutting unit side panels. New steel inserts are available to reinforce side panels.

1. Order and install parts listed below. See photo. [89960_2.jpg](#)
